Phase II Site Investigation Report, Generic Quantitative Risk Assessment (GQRA) and Gas Risk Assessment

at Land Off Cheney Row,
Walthamstow, London,
E17 5ED

Report Reference: LPI428

Report Date: 29th September 2017

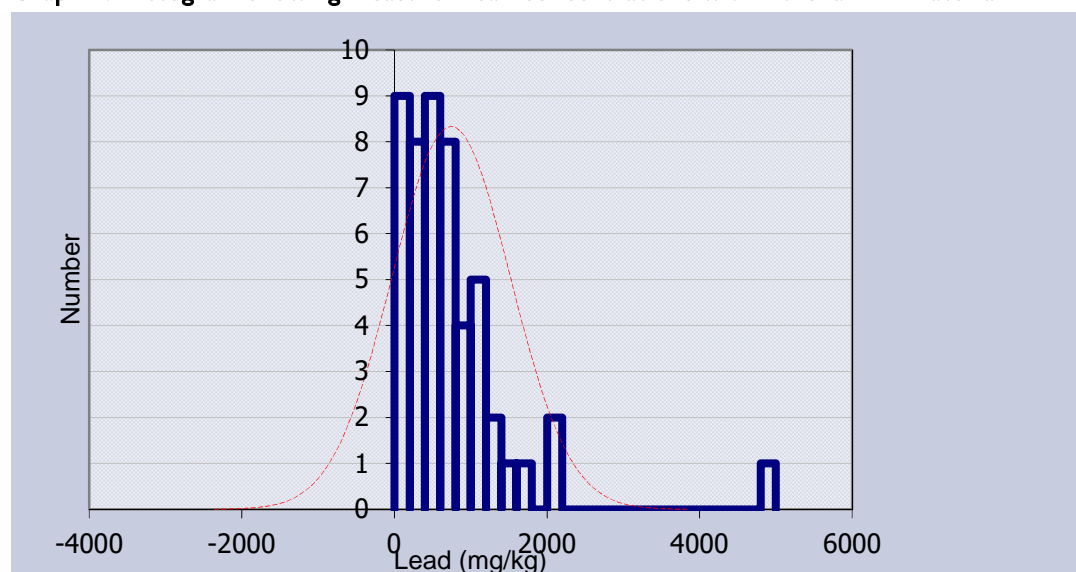
The results from the chemical analysis of soils recovered from the Landfill were subject to statistical analysis. The results identified a number of outliers within the dataset and as such the population of outliers has been assessed separately. Graph I below shows the histogram plot for lead at the site, clearly showing the outliers outside the normal distribution of the remaining results. The statistical analysis excluding outliers is presented in Table 6.

Graph 1: Histogram showing measured lead concentrations within the landfill material

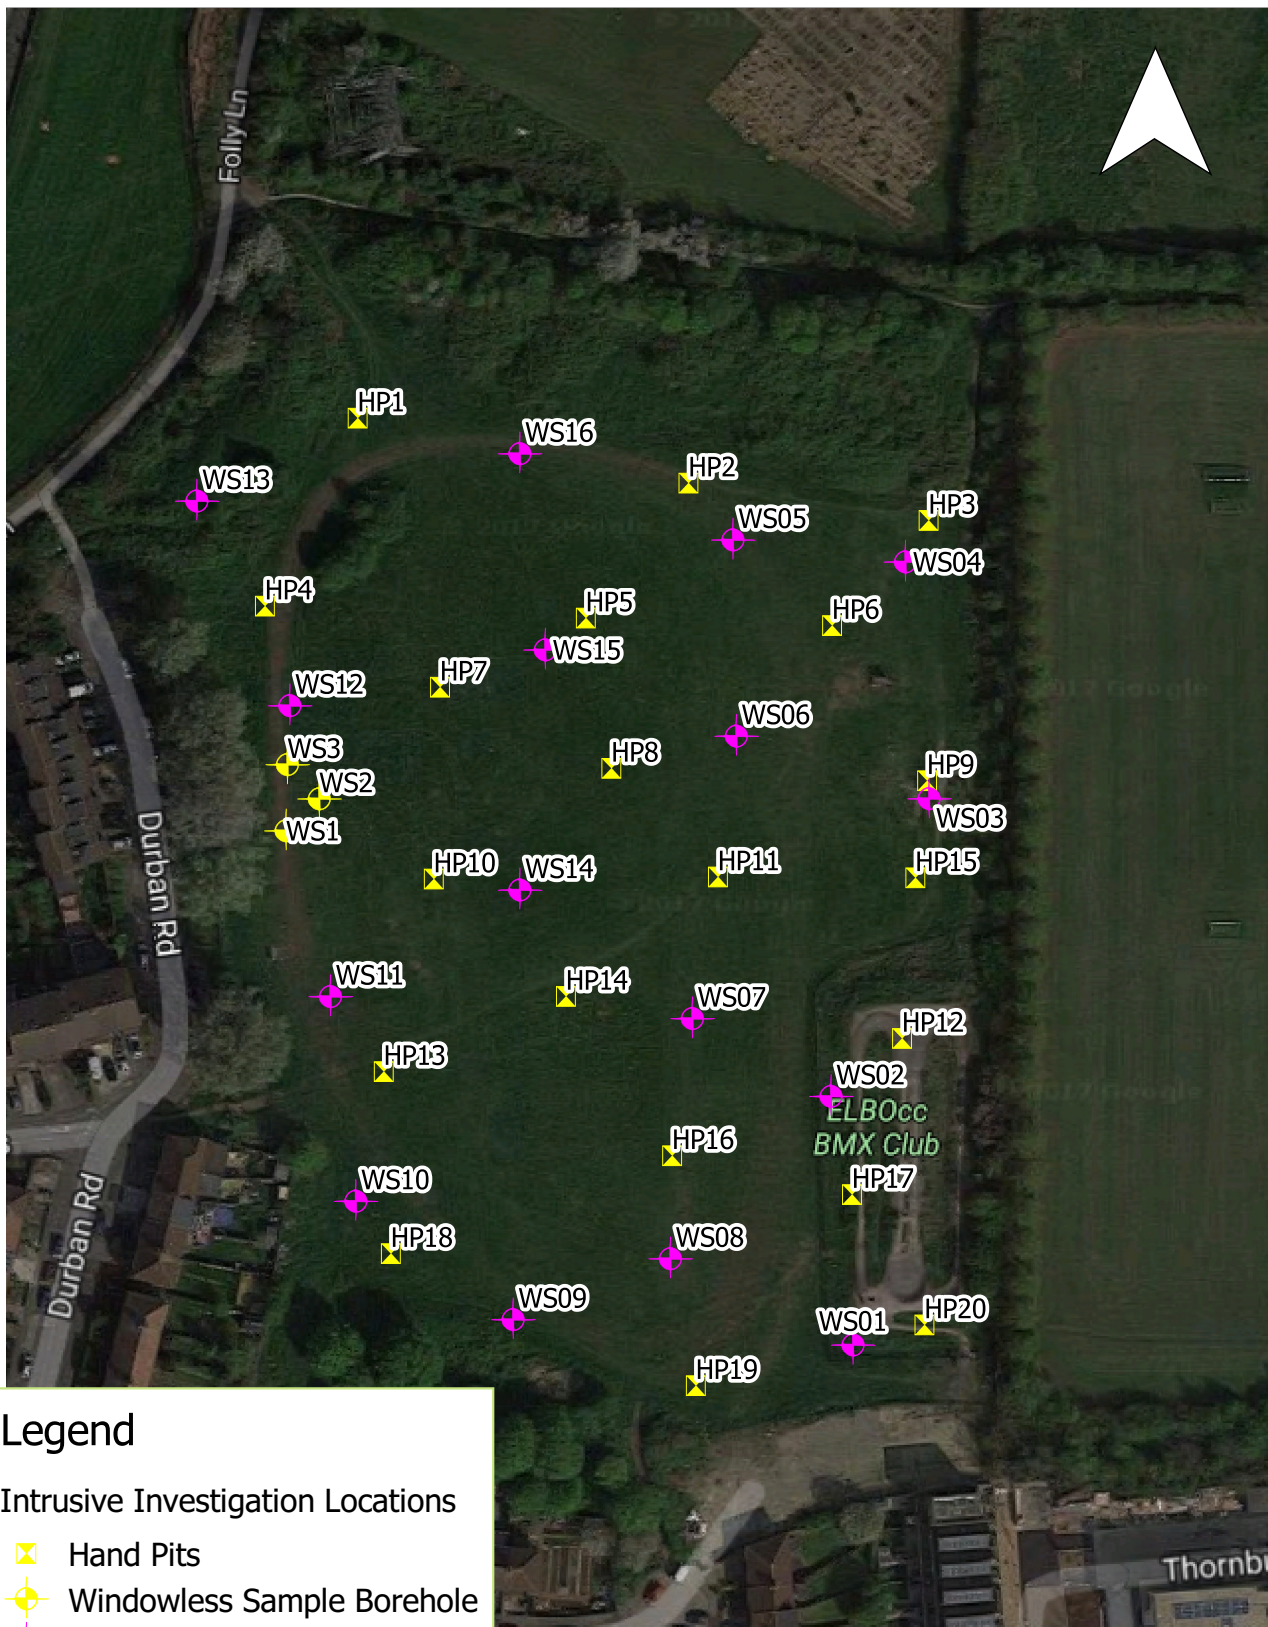
3

Intrusive Investigation Locations

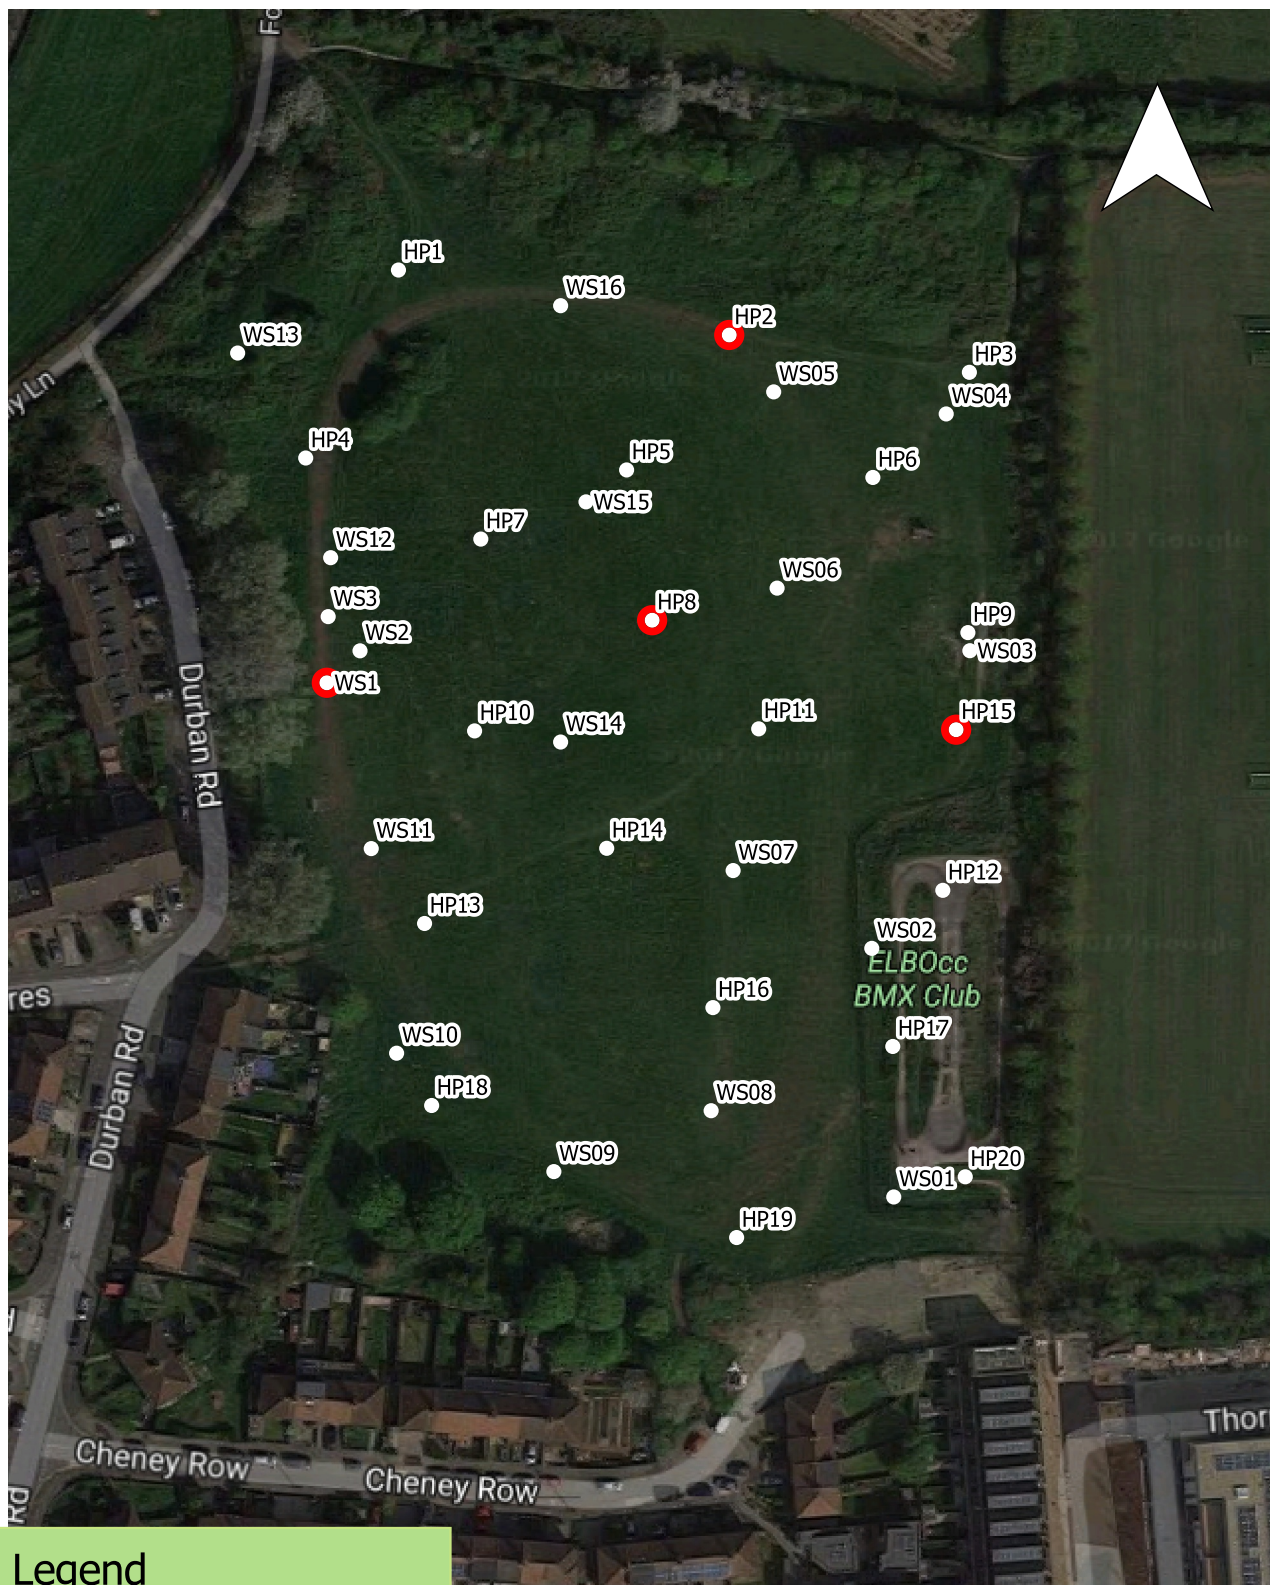
| Project: | Cheney Row | Date: | 12/09/2017 | Figure No. | 4 |

Figure 4 shows the four asbestos detections were found in the northern part of the site. Asbestos was found as a fragment in each of these four locations and was not found as free fibres. There are no set GAC for asbestos and therefore presence of asbestos is considered to be a potential risk to human health.

- Removal of the landfilled material in its entirety and replacement with clean imported soil i.e. Cut and Fill; or
- Importation of clean soil to be placed over a geotextile across the entire site as a cover system.
- A combination of the two, with partial excavation and then placement of clean cover to raise the levels back up.

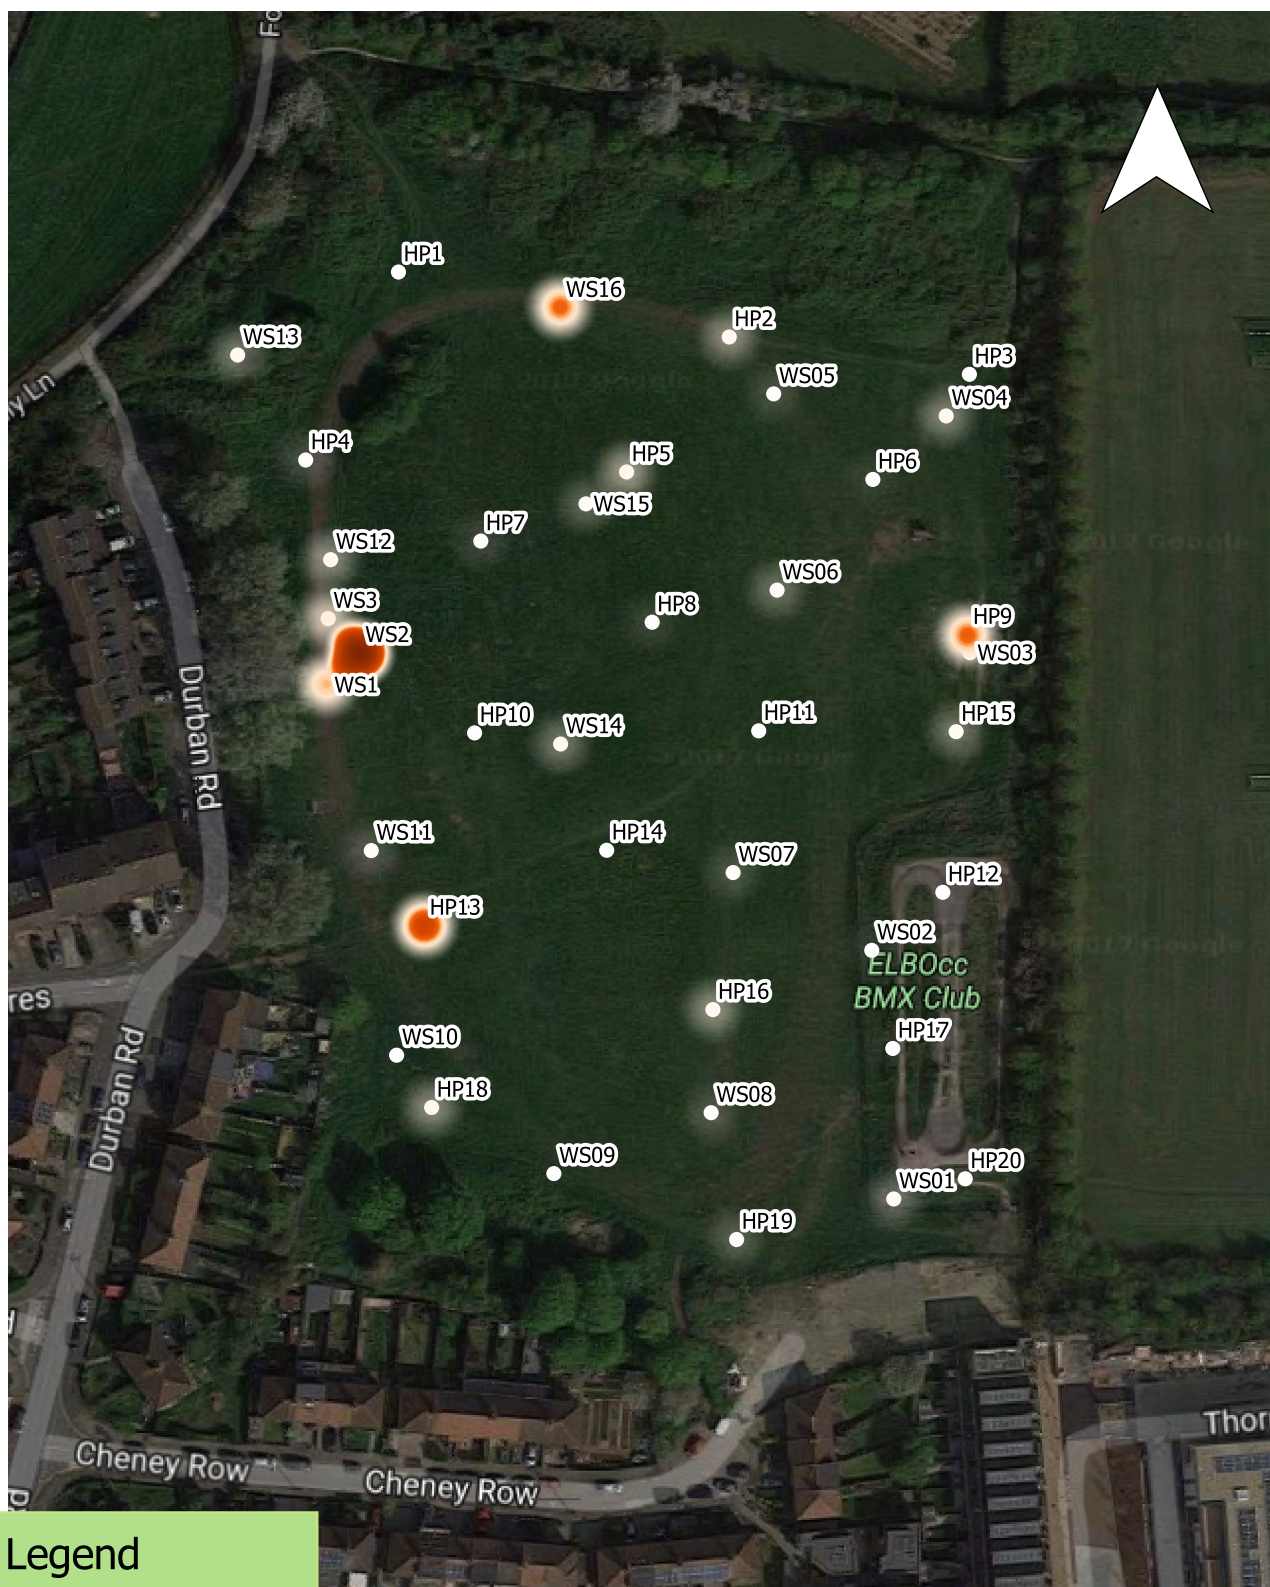
Figure No. 5

Figure 5 shows a heat map for Lead. The concentrations of lead determine whether the colour is light or dark, with light being the lowest and dark being the highest. The size of the 'halo' is not representative of the physical size or footprint of the hotspot. The darkest colours show the exceedances of the GAC which were found in WS2, HP9, HPI3 from this investigation and WS16 from the AMEC investigation. The spatial variability shows that there are multiple hotspots onsite and remediation would be necessary in these areas to lower the risk to human health.

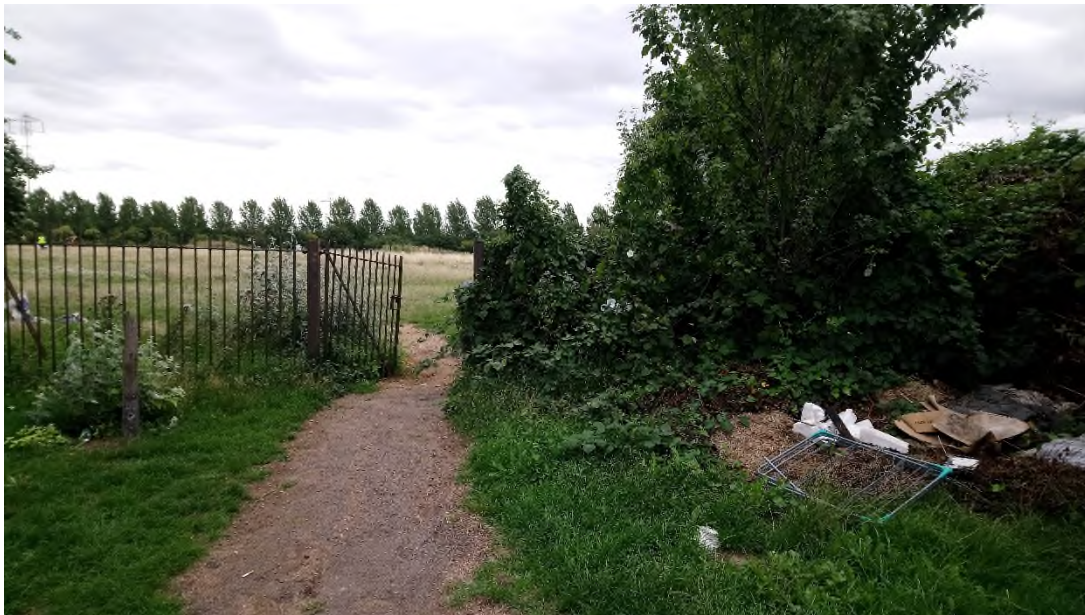
Photo 1 – Gated site entrance and fly tipped material offsite.

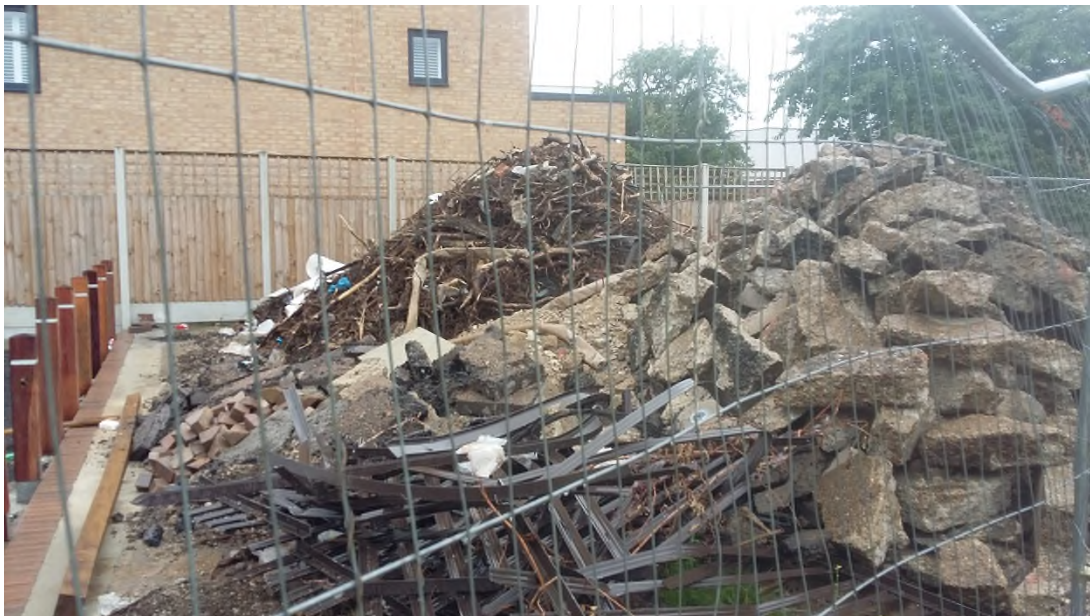
Photo 6 – Material stockpiled in the Car Park.

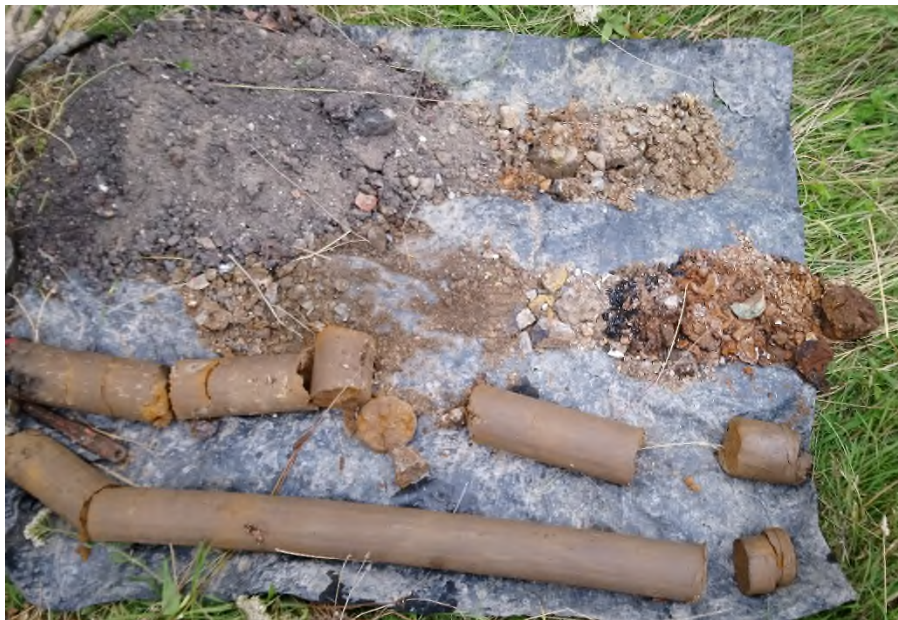
Photo 8 – Photograph of the arisings from WSI.

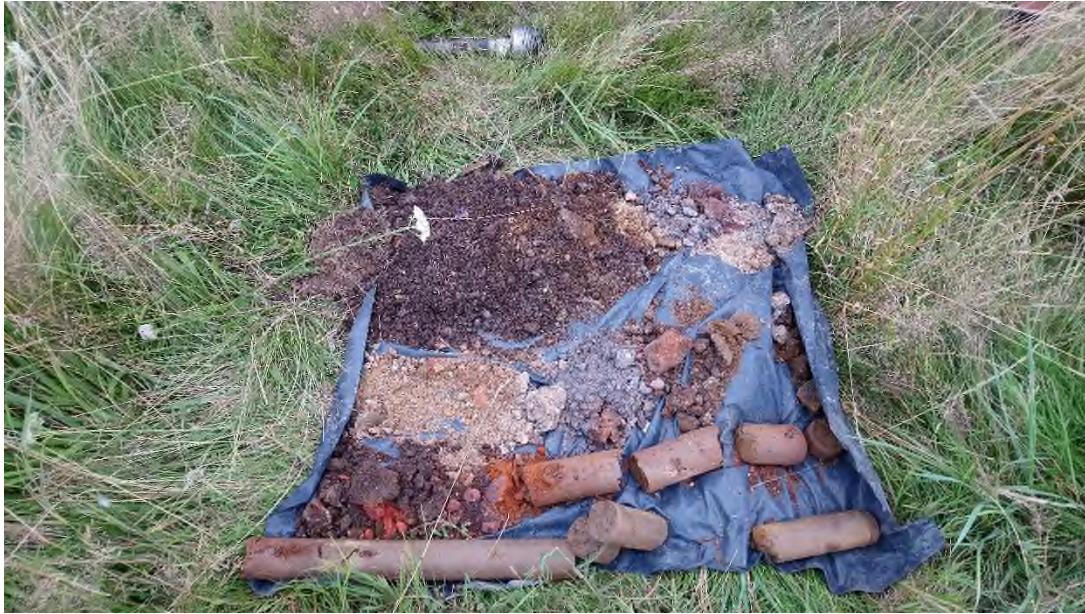
Exceedances for Lead were found at various depths within the Made Ground, with the maximum concentration of 4830mg/kg reported within WS2 at 0.5m. The results for Benzo(a)Pyrene followed a similar trend although no exceedances were identified within the AMEC and Carpenter and Lowe investigations. The maximum concentration of Benzo(a)Pyrene reported was found in HP9 at 68mg/kg.

Photo 9 – Photograph of the arisings from WS2.

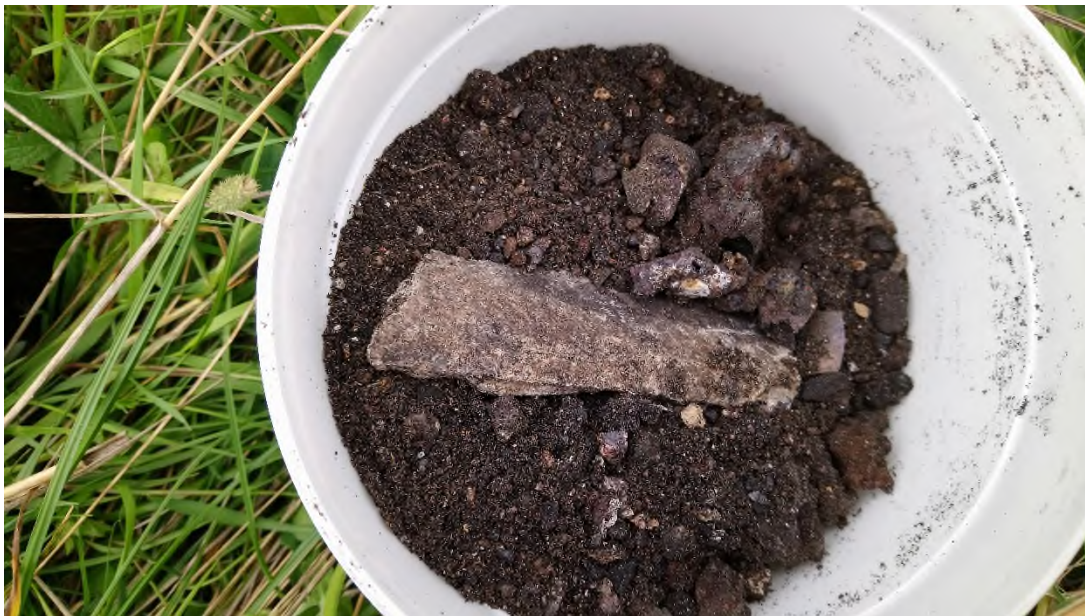
Visual and olfactory evidence of contamination noted during the investigation works is summarised in Table 4. Suspected Asbestos fragments and ash were identified within the Made Ground landfill in areas across the site.

Photo 10 – Suspected Asbestos Cement.

The presence of asbestos may be noted during the site walkover survey, intrusive investigations and/or from the results of contamination testing. However, this report does not constitute an asbestos survey. On this basis, the presence of asbestos on site cannot be discounted and a full asbestos survey should be undertaken.

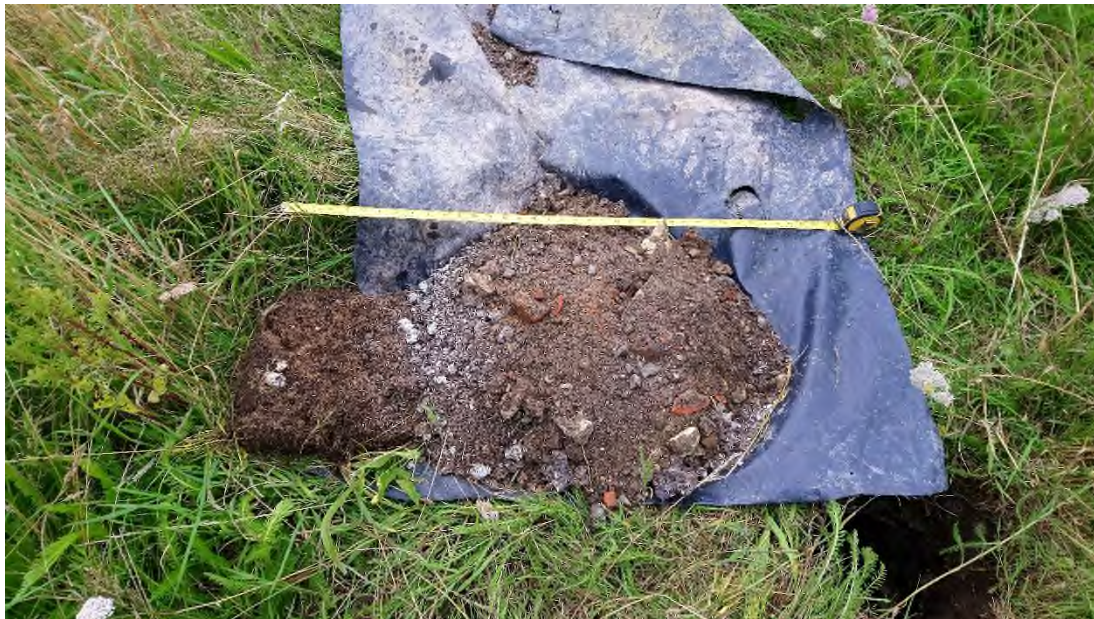
Photo 11 – Photograph of the arisings from WS3.

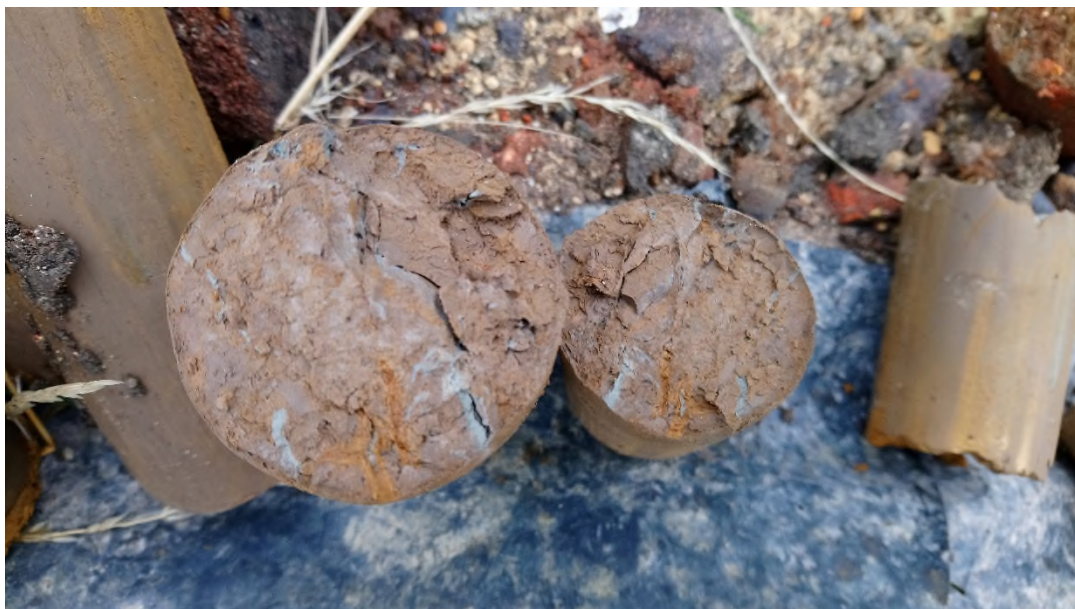
The Natural soils were encountered within the Windowless Sampler Boreholes at a minimum depth of 2.1m. The natural soils were found to be stiff, orange, brown and blue silty Clay with selenite crystals.

Photo 12 – Photograph of the Clay beneath the Fill.
